Experimental investigation on the fire resistance of cast-in-situ hollow core concrete slabs constructed using filler boxes and an assembly box system

Junli Lyu ^a, Yong Wang ^{b*}, Ruben Van Coile ^c, Zhaohui Huang ^d, Yuner Huang ^e

Abstract: This paper presents the results of four fire tests on full-scale cast-in-situ, hollow core concrete slabs, constructed using filler boxes and an assembly box system. Experimental data include the furnace temperature, temperature distribution in the slab, and vertical and horizontal deflections during the heating and cooling phases, as well as observed cracking patterns. The test data indicate that the tested hollow slabs with plastic filler boxes have good performance in case of standard fire exposure with small vertical deflections and high deflection recovery in long duration testing. For slabs with assembly box systems serious spalling was observed, resulting in integrity failure after 69 minutes in one of the tests. Nevertheless, load bearing capacity was maintained for all tests. The tests highlight the importance of the boundary conditions and the arrangement of the filler system on the fire behaviour of the hollow slabs, particularl

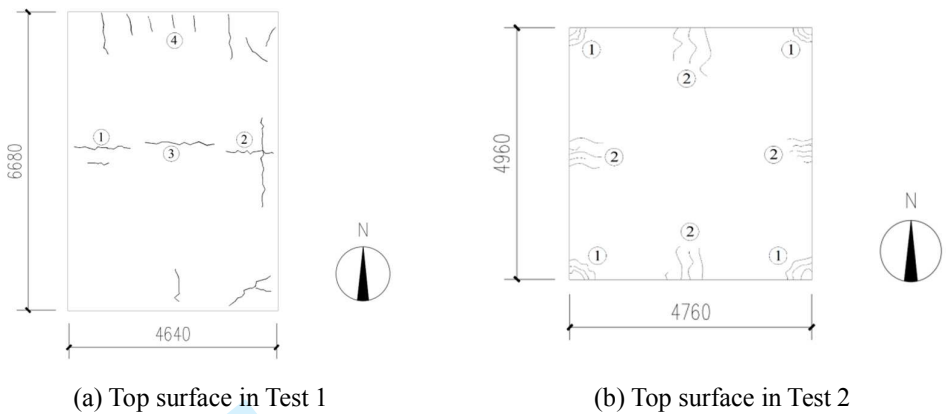
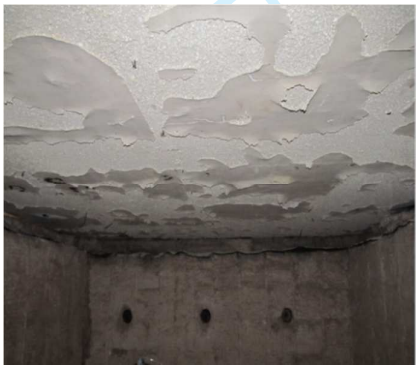
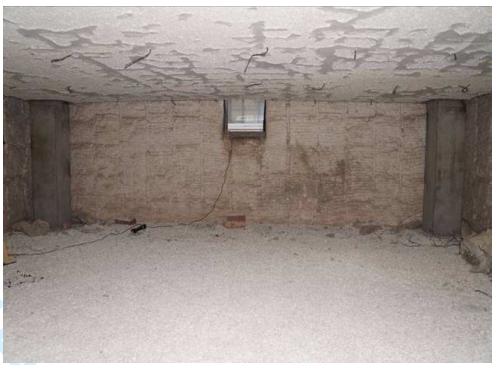
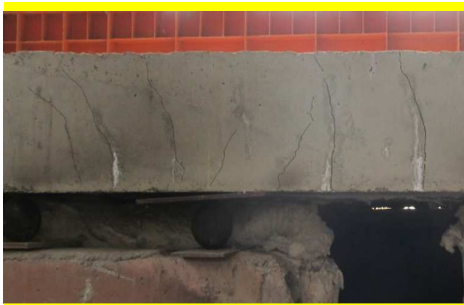
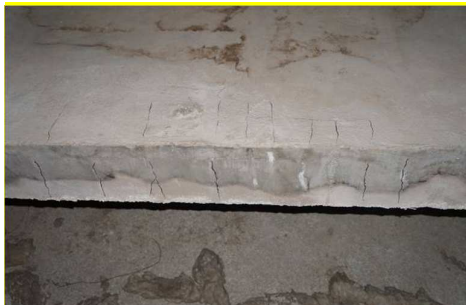
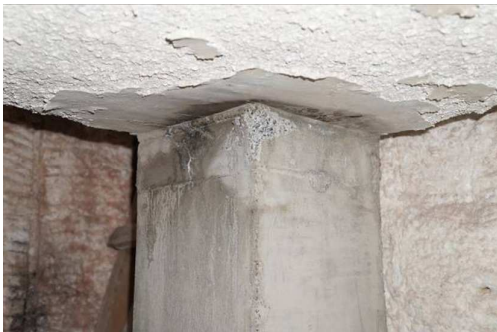
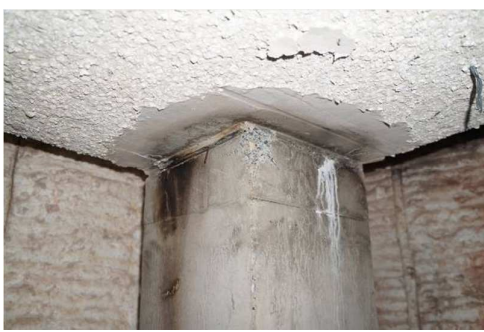
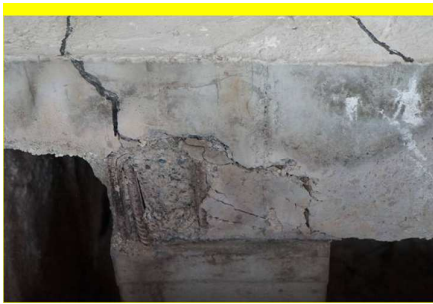
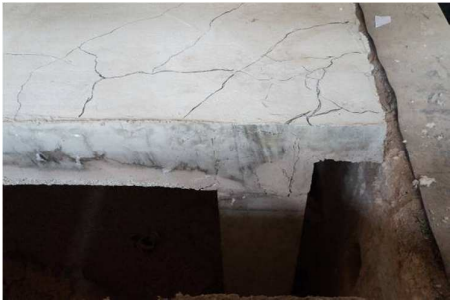
Fig. 11 Cracking pattern, spalling and failure of the hollow slabs in Tests 1 and 2

Cracking of the simply supported hollow slab (Test 1) was observed during the test, as shown in Fig.11 (a). As expected, several minutes after ignition, its four corners gradually curled due to the unclamped corners and diagonal cracks could be seen at the corners of the top surface. At approximately 30 min, several cracks (denoted ①, ② and ③) formed on the top surface of the hollow slab. Meanwhile, water and steam started to seep through the cracks. As the test continued, a large amount of water simultaneously seeped through these cracks and accumulated, after which a large amount of steam was driven off. In addition, the crack (denoted ④) across the section of the edge beams gradually appeared in the test. At 1

hour and 50 min, the puddle of water on the top surface of the slab dried up. Finally, the cracking pattern appears on the unheated surface of the slab, as shown in Fig. 11 (a). It can be seen that the central crack (①, ② and ③) tended to be formed across the transverse direction of the slab, this crack pattern was similar to the crack which appears on the conventional simply-supported concrete slabs (Lim and Wade, 2002; Wang and Dong, 2009).

Fig. 11(b) shows the cracking pattern on the top of the column-supported hollow slab. Twenty minutes after ignition, many diagonal cracks (denoted ①) rapidly formed at the corners of the slab adjacent to the columns. Clearly, this behavior is due to the restraint of the column against the curling of the heated slabs. Similarly, water and steam started to seep through the cracks. As the test continues, several major cracks (denoted ②) developed perpendicular to the edge beams. Finally, the crack pattern observed in the slab is shown in Fig. 11(b). Clearly, the cracking pattern in Test 2 was different from that observed in Test 1, and fewer cracks were observed on the central region of the top surface in Test 2. Thus, the comparisons of the cracking patterns for the two slabs indicate that the boundary condition has an important effect on the number and direction of the cracking within the hollow slabs.

Failure mode on the bottom surface of two hollow slabs (Tests 1 and 2) was observed after the test, as shown in Figs. 11 (c) and 11(d). Serious spalling did not occur in the two tests, and thus the two slabs with plastic filler boxes had good fire resistance performance and structural stiffness.

As shown in Figs. 11(e) and 11(f), full-depth cracks appeared at the edge beams in Tests 1 and 2. In addition, due to the mineral wool protection, little spalling occurred in the concrete columns (Test 2), as shown in Figs. 11(d), 11(g) and 11(h). However, as shown in Figs. 11(i) and 11(j), the concrete failure of two beam-column connections (i.e., south-east and north-east corners) occurred in Test 2 due to the negative moment, and thus the connections in Test 2 should be reinforced to enhance their fire-resistant performance.

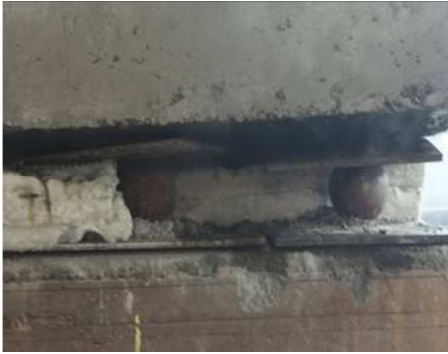
(a) Curled corner

The following phenomena were observed during the testing of the simply-supported slab in Test 3. Several minutes after ignition, through the viewing ports, the water was seen on the bottom surface of the slab, falling to the ground of the furnace. After that, some noise was heard due to the spalling of the concrete assembly boxes. At approximately 20 min, the bottom failure of several assembly boxes occurred due to the spalling, and thus the bottom reinforcing steel was also observed. It is noted that the very loud noise (spalling) was heard, and the vibration of the slab was observed at the same time. At approximately 25 min, water and steam started to seep through the cracks (on the top surface). Meanwhile, four corners of the slab gradually curled due to the unclamped corners, as shown in Fig. 12 (a). As the test continued, a large amount of water simultaneously seeped through these cracks and accumulated, after which a large amount of steam was driven off, as shown in Fig. 12(b). At that point, the cracking on the unheated surface of the slab could not be observed due to the steam. At 69 min, as shown in Fig. 12(c), one hole was observed on the top surface of the concrete assembly box, and then a flame was observed. Hence, the integrity failure of the slab occurred due to the spalling of the concrete assembly box. At 80 min, three further holes were observed on the top surface of the slab due to the spalling of the assembly boxes (bottom plates), so the hot gases escaped through the holes. At 90 min, the test was stopped in consideration of the safety.

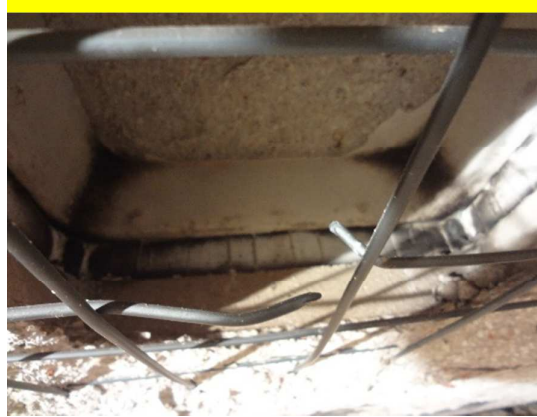
(e) Steel fracture and spalling of the assembly box

“In addition, as shown in Fig. 12(e), the steel fracture in the assembly box occurred, and the spalling also appeared on the top plate. However, it is interesting to note that all the ribbed beams did not show the signs of serious spalling.”

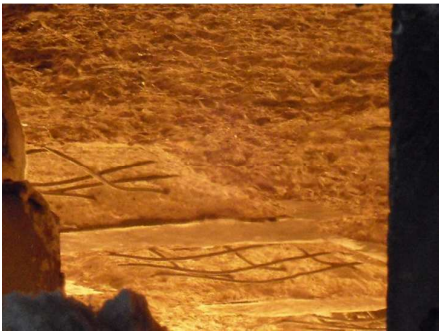
(a) Concrete spalling of the bottom plate

For Test 4, several minutes after ignition, the noise was heard due to the concrete spalling, and the reinforcing steel could be seen through the viewing port, as shown in Fig. 13(a). It is noted that the concrete spalling, the noise and the vibration lasted until about 40 min. Meanwhile, similar to that of Test 3, water and steam could be seen on the top surface of the slab. At about 40 min, four corners of the slab gradually curled. In addition, the test was stopped from 46 min to 51 min due to the malfunction of the fan. As shown in Fig. 13(b), through the viewing ports, the bottom surfaces of many assembly boxes (bottom plates)

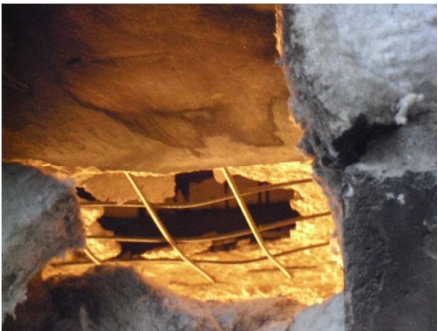
(b) Spalling of assembly box

showed signs of serious spalling. At about 70 min, a large amount of water simultaneously seeped through the cracks (top surface) and accumulated, and steam was driven off. Meanwhile, water appeared on the edge beams of the slab, and some inclined cracks (spacing of 300 mm) were observed, as shown in Fig. 13(c). At 292 min, due to the spalling (bottom surfaces) of many assembly concrete boxes, the test was ended. However, different from that of Test 3, no hole was found on the top surface of Test 4 during the heating phase. Hence, the upper cast-in-situ concrete was beneficial to enhance the fire-resistant performance of the hollow slab, particularly the integrity. Similar to that of Test 3, due to the serious spalling, a lot of concrete on the bottom surface had fallen off, and thus the steel bars exposed, as shown in Figs. 13(d) and 13(e). Hence, some methods should be used to reduce the risk of the explosive spalling in the unexposed or exposed assembly boxes. For example, the section shape or section size can be improved and the steel or polypropylene fibers added in the concrete mixes (Majorana et al., 2010). In addition, the slight spalling occurred on the bottom surfaces of the ribbed beams, but no reinforcing steels were observed on the ribbed beams.

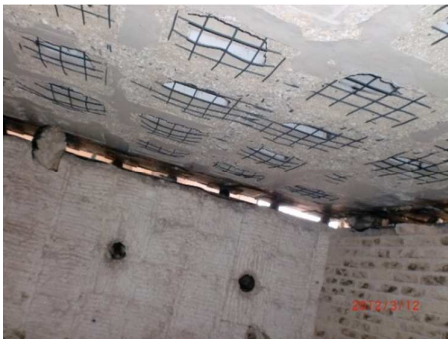
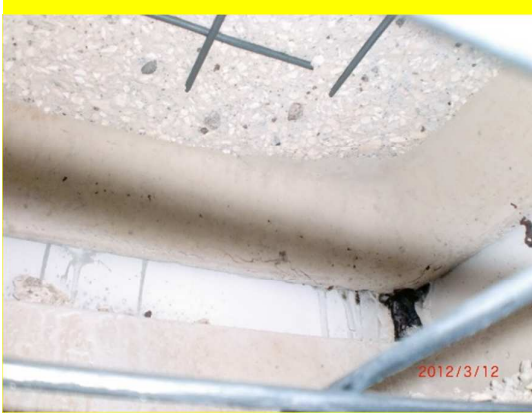
“Similar to that of Test 3, due to the serious spalling, a lot of concrete on the bottom surface had fallen off, and thus the steel bars exposed, as shown in Figs. 13(d) and 13(e). Hence, some methods should be used to reduce the risk of the explosive spalling in the unexposed or exposed assembly boxes. For example, the section shape or section size can be improved and the steel or polypropylene fibers added in the concrete mixes (Majorana et al., 2010).”
